Laser Doppler Vibrometry  
for analyzing high-voltage  
electric motor terminals

# Reliable electric mobility starts with the details //

## **LASER DOPPLER VIBROMETRY PROVIDES INSIGHTS INTO THE VIBRATION BEHAVIOR OF HIGH-VOLTAGE ELECTRIC MOTOR TERMINALS**

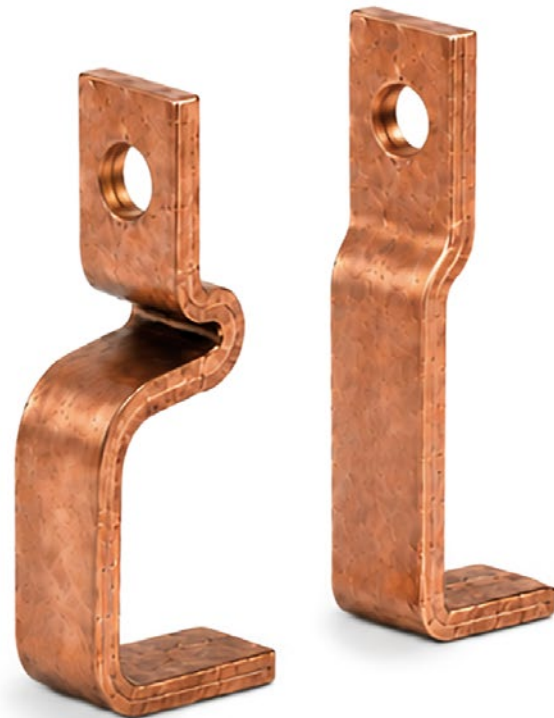
In this application, the goal is to characterize the vibro-mechanical behavior of AC connection terminals with a lamellar design and to compare two different geometries, S-type and L-type, in terms of their service life and damage resistance in a resonance dwell test (Fig. 2).

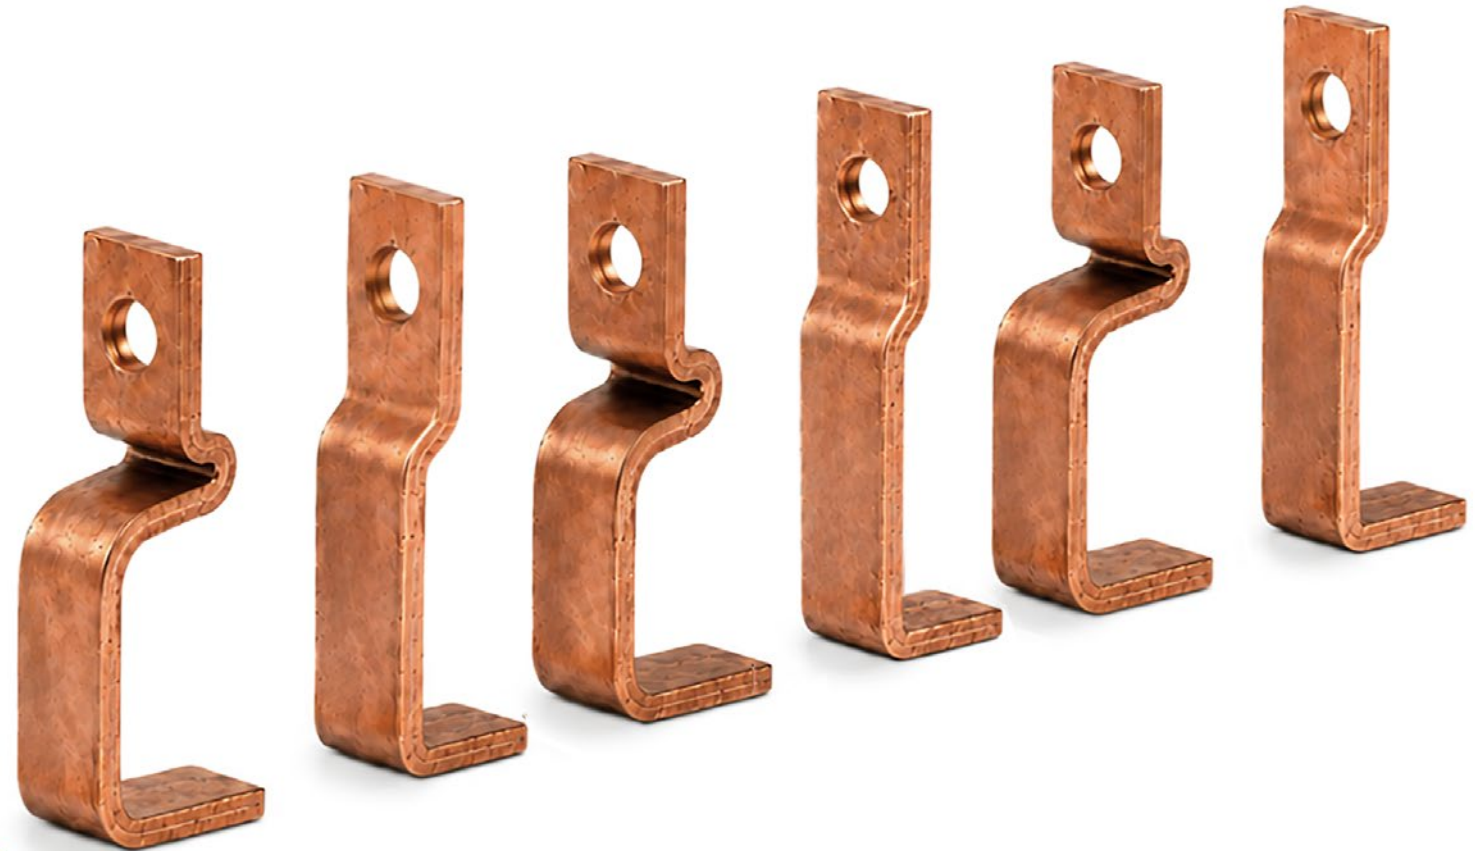
A crack in the lamellae, as shown in Fig. 4, reduces the conductive cross-section and thus the conductivity of the terminal. Resistance increases, causing the component to heat up. This can lead to total failure.

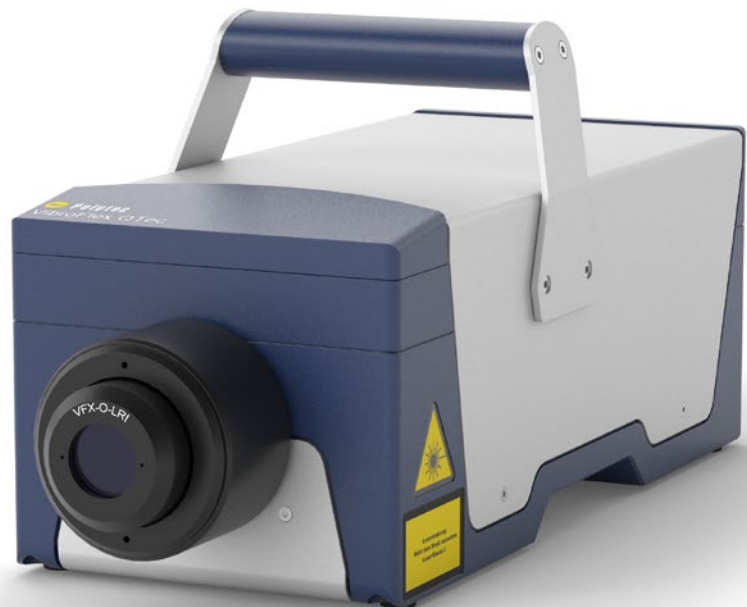
3 VibroFlex QTec sensor head

A central element of the methodology was the use of a VibroFlex QTec Laser Doppler Vibrometer (LDV) from Polytec GmbH (Fig. 3), which offers decisive advantages over conventional accelerometers.

While conventional sensors distort the vibration behavior of lightweight structures due to their mass and the joint damping of the adhesive bond, the LDV enables non-contact and thus feedback-free measurement of the small and delicate lamellar clamps. For the measurement, it is sufficient to align and position the measuring laser on the test specimen, which not only shortens the measurement time but also significantly simplifies the placement of the component.

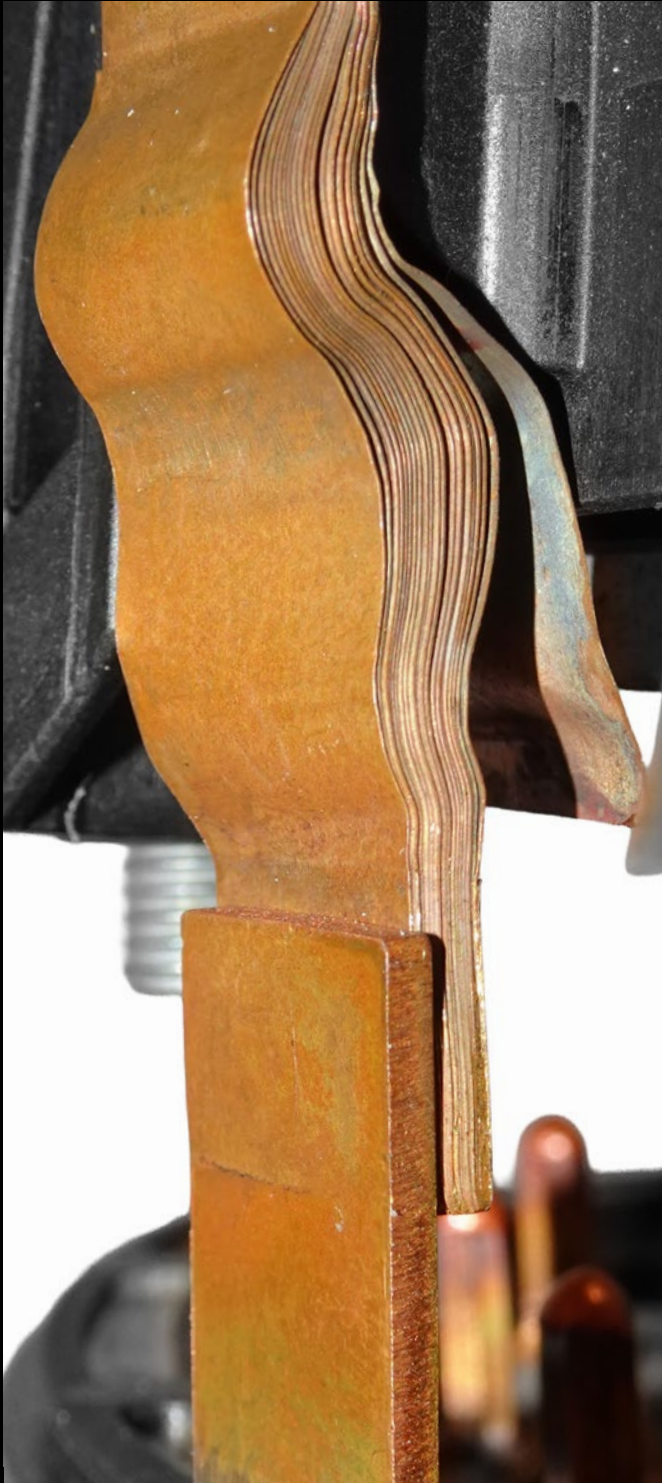
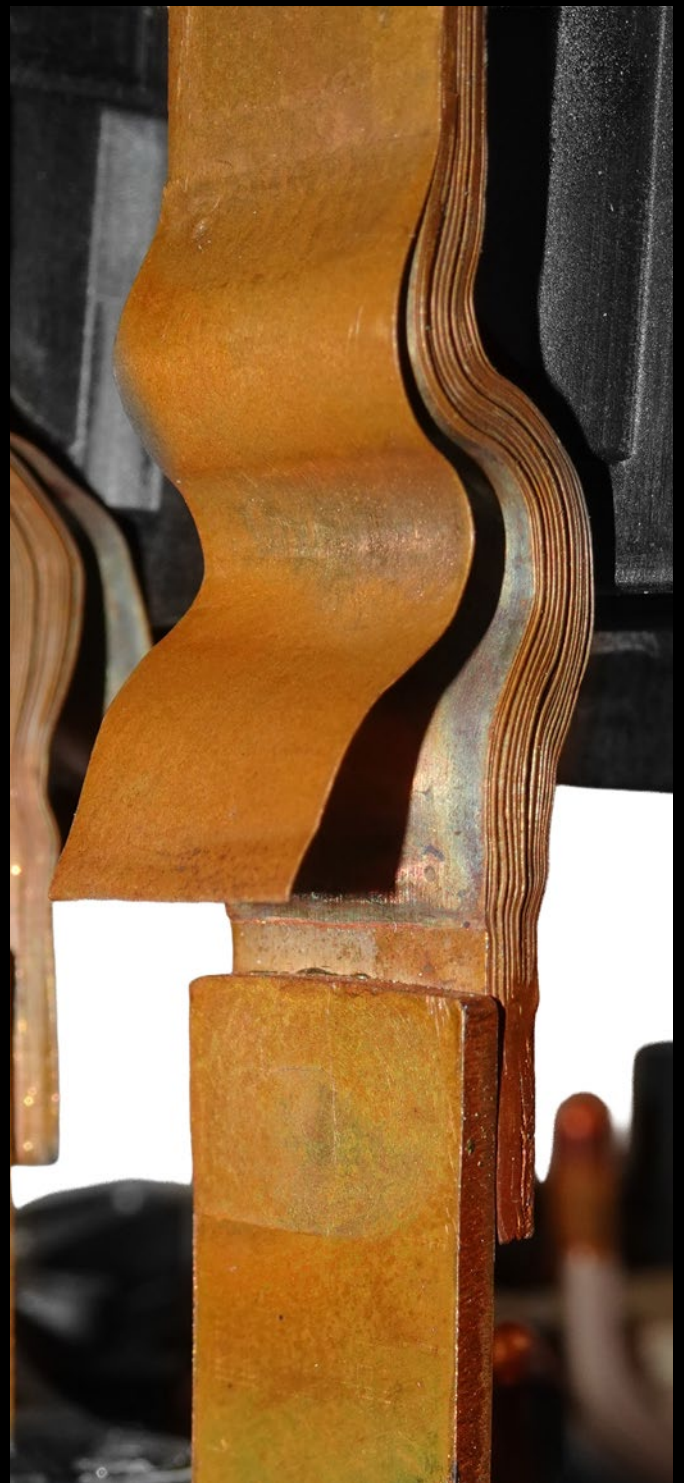
A total of 13 specimens of both geometric variants were subjected to a complete resonance dwell test. For all test specimens, a crack or initial crack in the outer lamellae was documented as the damage pattern. The first lamella crack was reliably detected based on the first distinct drop in resonance frequency (Fig. 5).
